DESCRIPTION:

One afternoon, researchers needed to re-fill their nitrogen Dewar. The Dewar was rolled from the research building to PMA where the nitrogen re-fill station is located. After filling, the researchers returned to their research building, reversing their original route they took to get to PMA. After exiting PMA and turning the corner at the edge of the building, the Dewar the researchers were pushing tipped over and nitrogen was leaked.

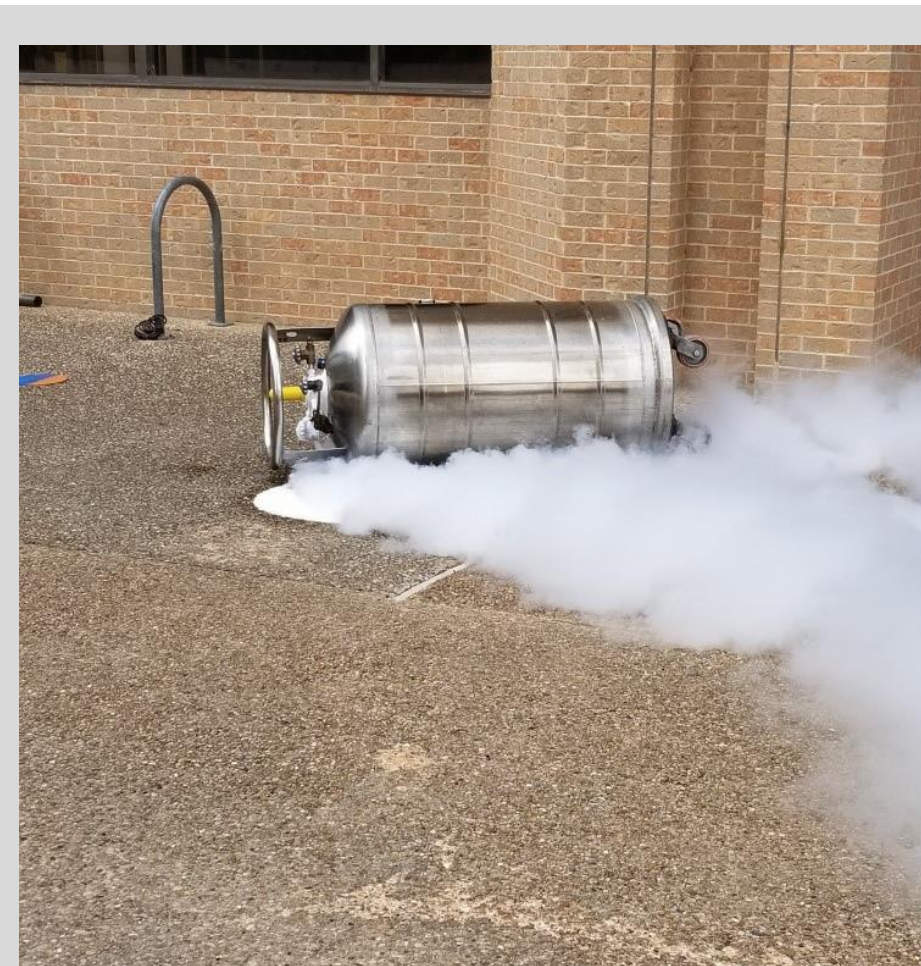
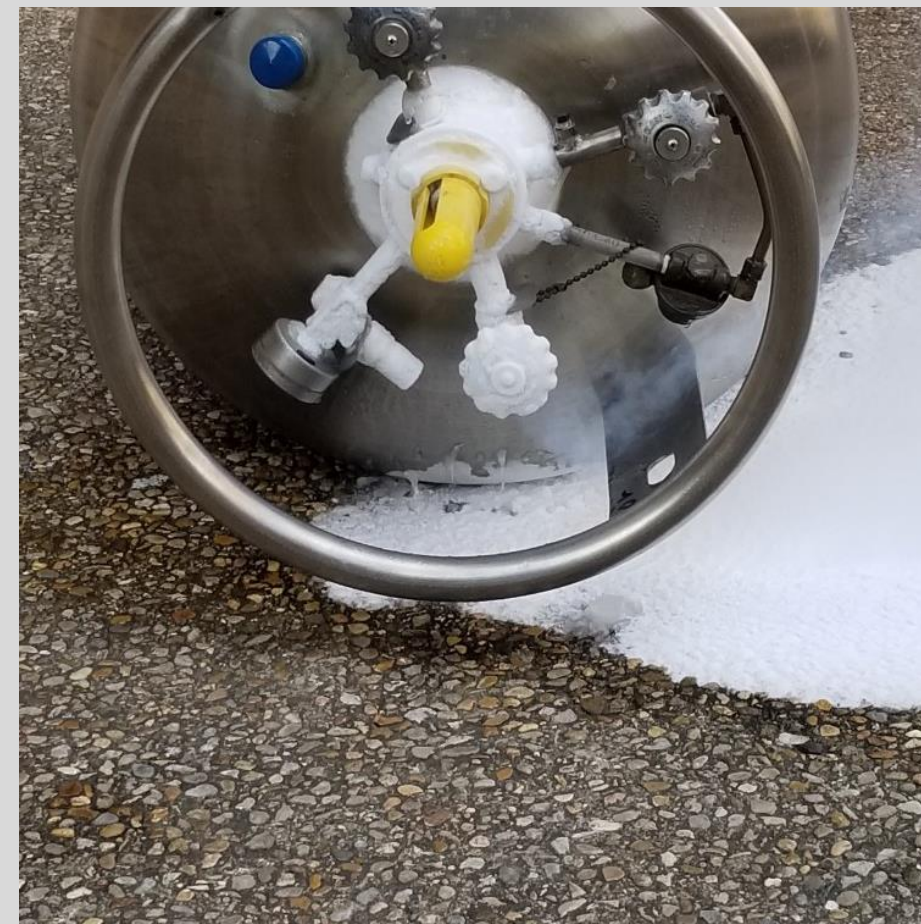
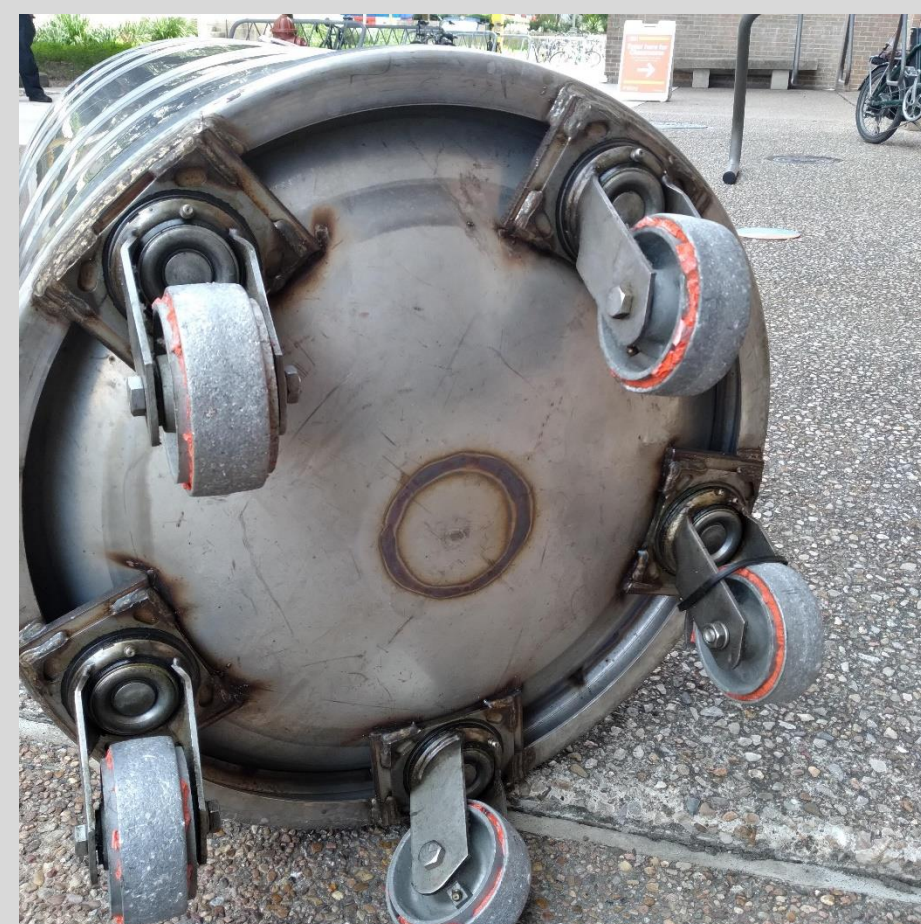
- The sidewalk had an uneven surface that caught the wheel(s) of the Dewar.
- Wheels on the Dewar were a custom modification and not a stable platform for the Dewar.
- Wheels were worn out and missing plastic wheel coating.
- Transport handle not present on Dewar configuration which resulted in pushing forward on the top half of the Dewar to create movement.

- Custom modification to a Dewar is not allowed without approval from departmental chair or EHS.
- Inspect your Dewar before transporting and filling with nitrogen to ensure it is in good working order. Do not use if modified (without approval) or damaged, or is missing parts.
- Look for uneven surfaces along the transportation pathway. Tripping hazards such as uneven sidewalks can be reported for repairs by calling 1-2020.
