# LAB INCIDENT SUMMARY: CRYOGEN RELEASE

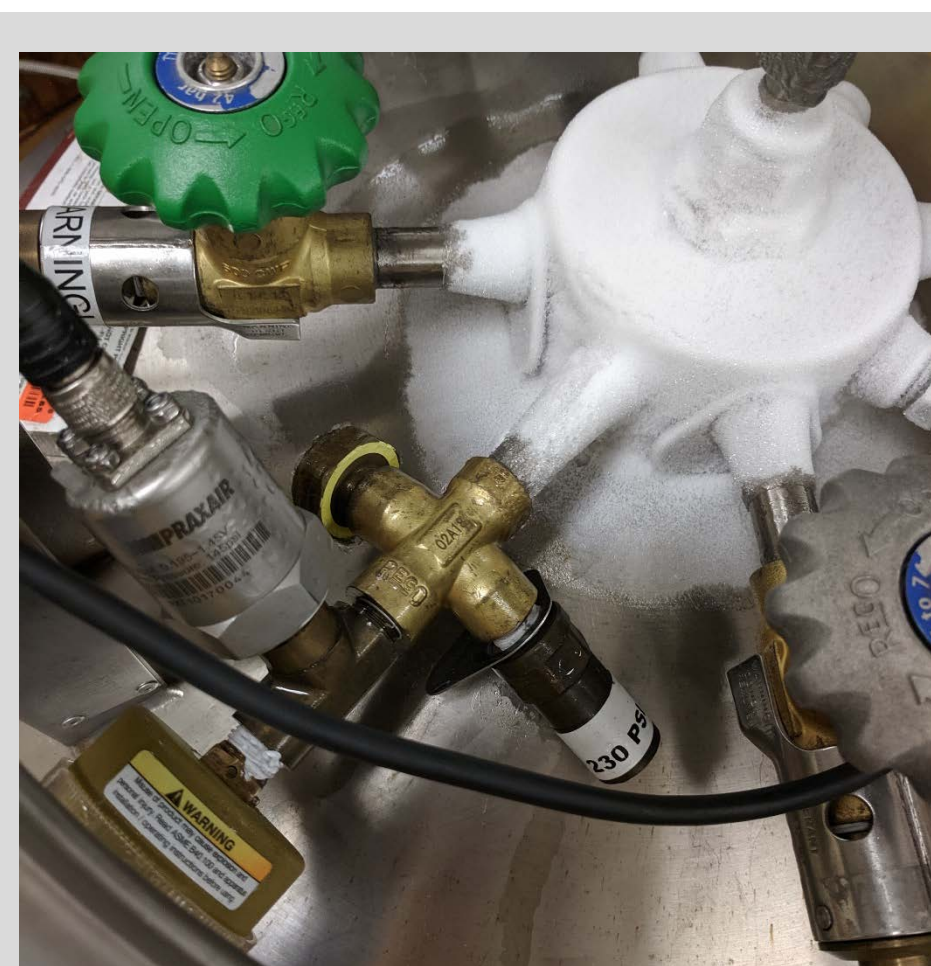
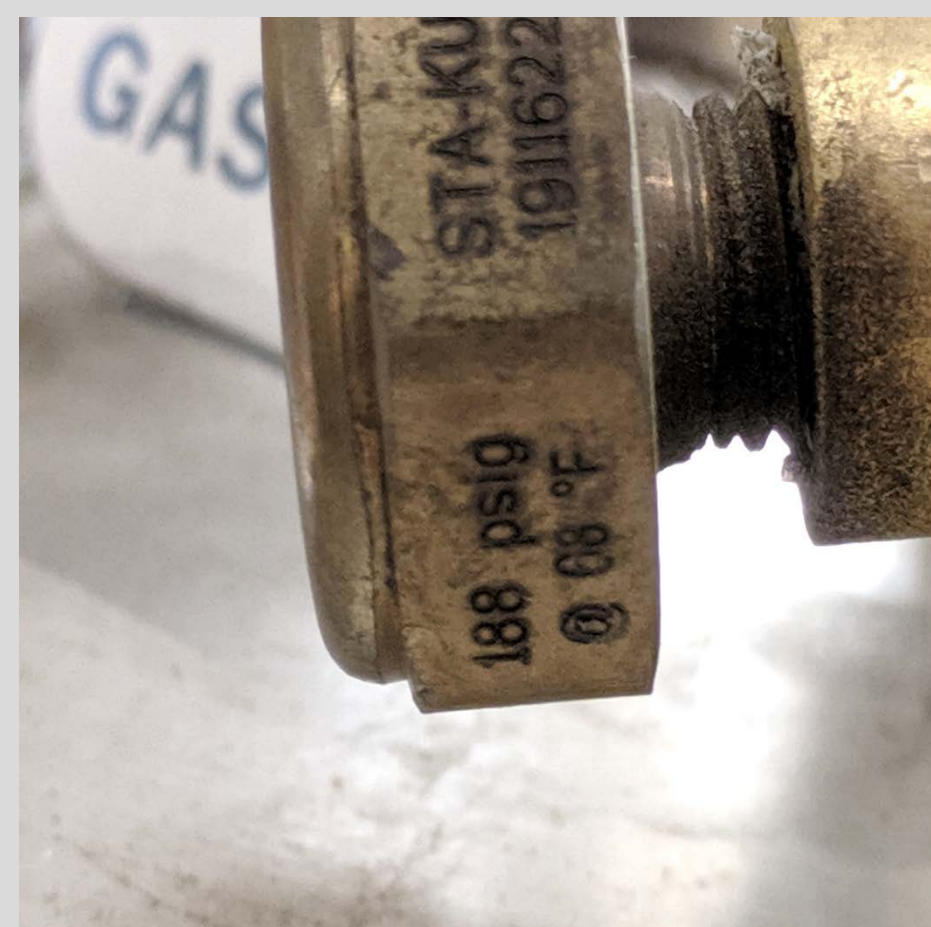
- EHS called the building manager to follow-up. The building manager suspected a gas cylinder release.
- EHS responded and entered the lab, using respiratory protection and a gas monitor. EHS determined that oxygen levels were acceptable. No hazardous gases were detected.
- EHS found that the inner vessel burst disc had ruptured on a tank of liquid argon. A 1L glass bottle of water had been knocked off a nearby cabinet, but remained intact.
- There was no one working in the lab at the time of the incident. There were no other spills/releases. The lab was cleared for reentry.

- Incorrect inner vessel burst disc installed
  - Tank was delivered one week prior and had appeared to be functioning normally (i.e., pressure relief valve was venting periodically)
  - Supplier confirmed that the inner vessel burst disc (188 psig) was rated lower than the pressure relief valve (230 psig), resulting in burst disc rupture and product loss

- Check the rating of burst discs on the tanks you receive
  - Inner vessel burst disc should be rated for double the pressure relief valve (varies; pressure relief valve should be labeled)
- Check position of burst disc when placing tank in a lab
  - Point away from high traffic areas, chemical containers, and sensitive equipment
- Ensure chemical inventories are entered in EHS Assistant for each lab room
  - Without a current chemical inventory, it is difficult to assess hazards prior to entering
  - Even if cryogen dissipated, still concerned about other chemicals that may have been damaged/leaking
